CLAM LAKE DAM  
MA 01052

PHASE I INSPECTION REPORT  
NATIONAL DAM INSPECTION PROGRAM

DEPARTMENT OF THE ARMY  
NEW ENGLAND DIVISION, CORPS OF ENGINEERS  
WALTHAM, MASS. 02154

FEBRUARY 1980

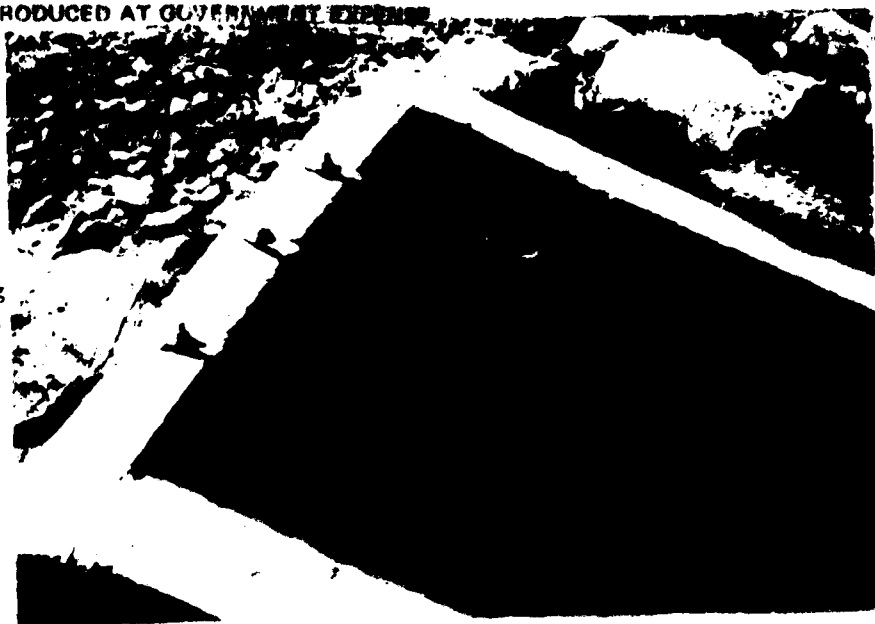
Photo 11

Gate well of principal spillway structure. Note the lower two stem guides are damaged.

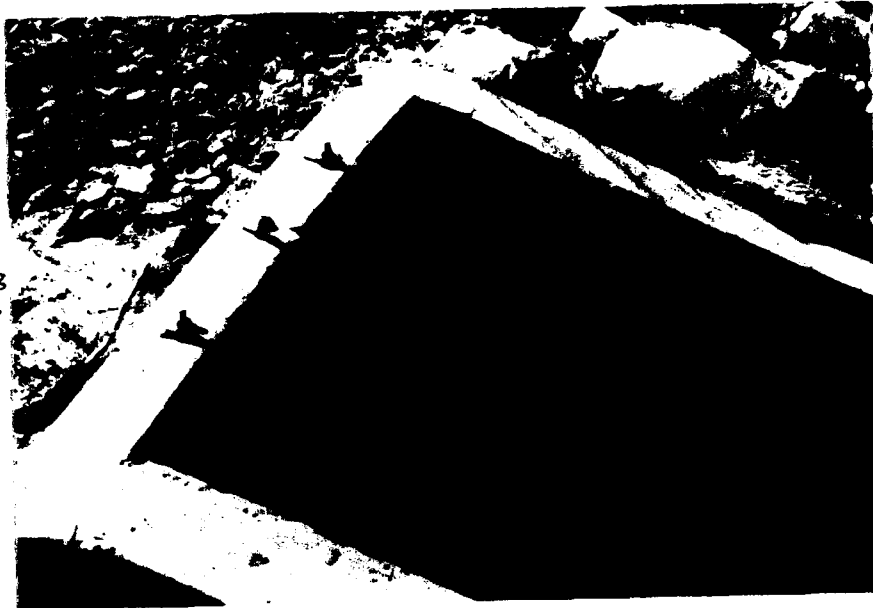
Photo 11

Gate well of principal spillway structure. Note the lower two stem guides are damaged.
